Technical Evaluation of the Gold King Mine Incident

San Juan County, Colorado

U.S. Department of the Interior
Bureau of Reclamation
Technical Service Center
Denver, Colorado

October 2015

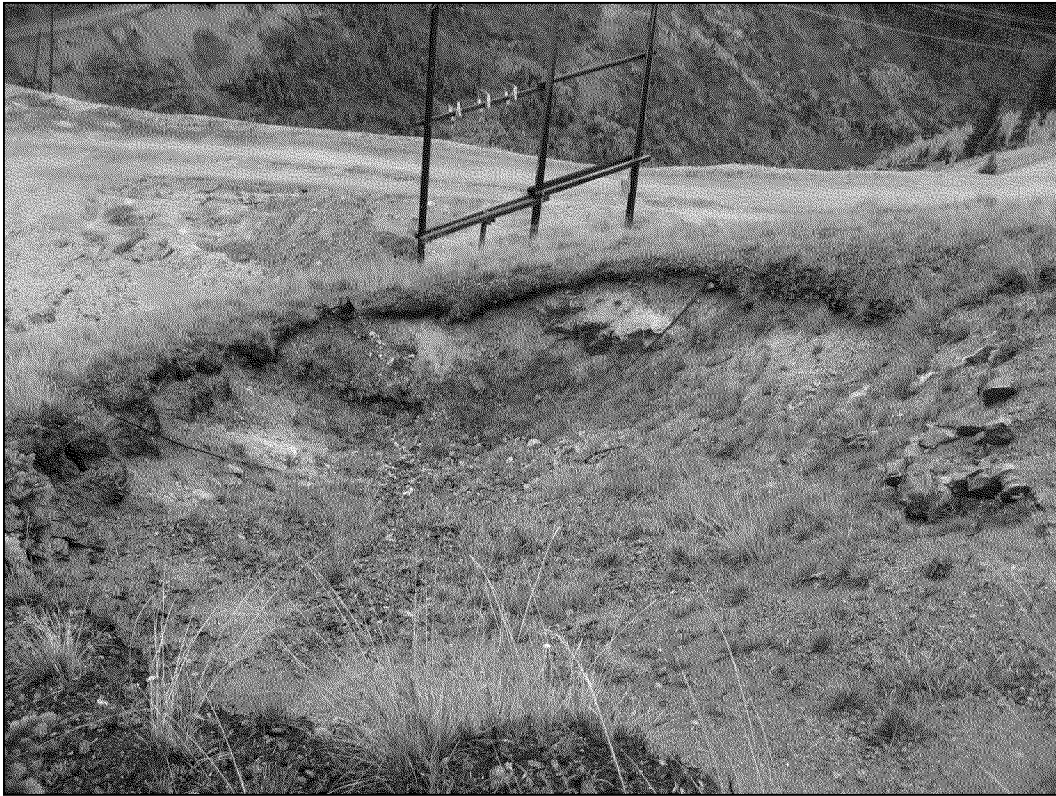
Figure 32.—Photograph taken on September 22, 2014, looking downhill at the subsidence pit located above the Gold King Mine Level 7 Old Adit.

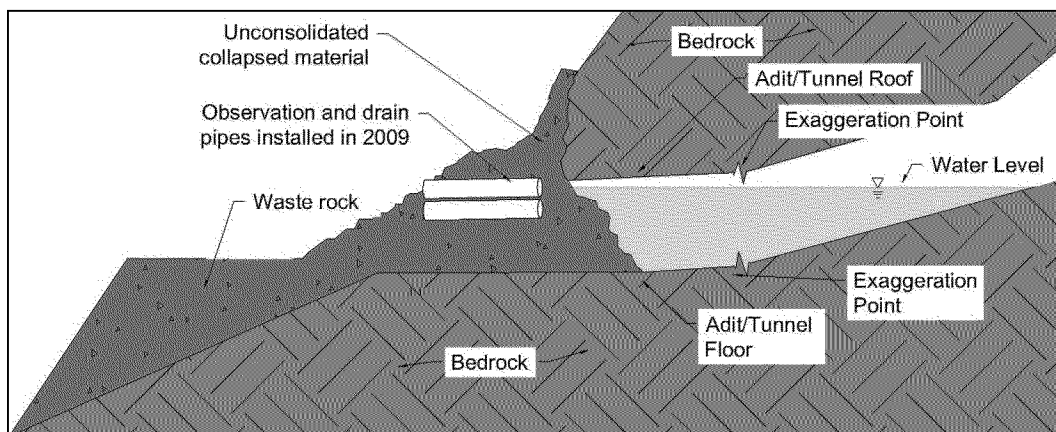
Figure 40.—Cross-section illustration showing the condition of the adit that was assumed by the EPA OSC and the abandoned mine experts from DRMS for use in planning to open the adit (not to scale). The “exaggeration point” means the right side of the drawing has an exaggerated vertical scale in order to show the 1% uphill slope of the adit. If drawn without exaggeration, the uphill slope of the adit would not be obvious on the drawing.
